# Impact of decadal change in basin morphometry due to Urbanization – Bengaluru, India

## ABSTRACT

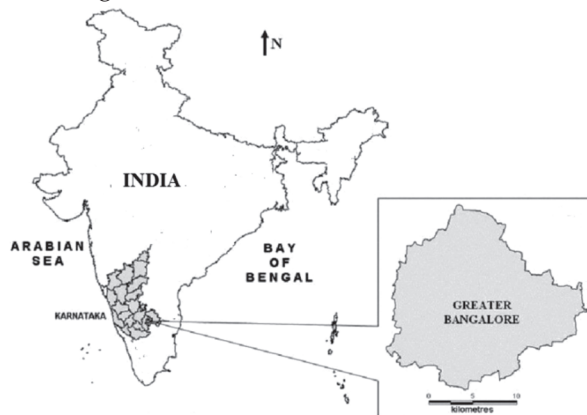
Fig. 1. Study Area

Greater Bangalore, has an areal extent of 741 square kilometres. Is the city termed as sillon valley of India. It is a place where people from all across the country come for and career development (Figure 1). Moving on to technical aspects of the study area, geomorphology of the city has intermingling hills and valleys more like a pediplains. The general geology of the area consists mainly of granite and gneissic with minor intrusions of pegmatite veins and dolerite and amphibolite dykes. There are tectonic impressions in fractures along the area which is responsible for hosting the ground water. Rainfall is a dynamic factor in basin morphometry, the rainfall patterns and fluctuations, rainfall mean and peaks are imperative. A century rainfall data was obtained. The normal rainfall of Bangalore urban is about 831 mm (Department of Statistics, Government of Karnataka, 2018). The precipitation is from two different wind patterns namely south-western monsoon which contributes 54.18% and northeastern monsoon contributes 26.53% with an additional precipitation from premonsoon showers of 18.53%. According to the Figure, (2 & 3) there is no major change in rainfall pattern, slight change is in the peak rain fall months. Earlier the rainfall peak was in august, september and october now in past six decades.

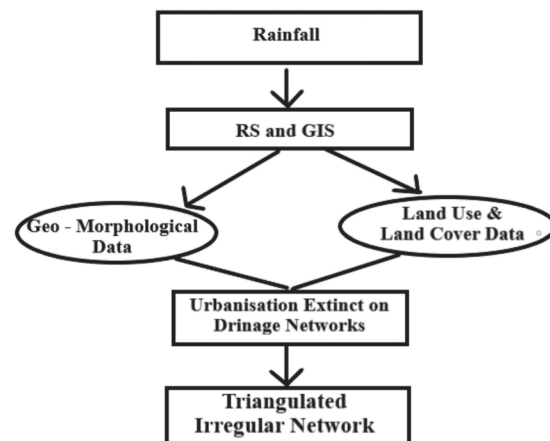
Fig. 4. Methodology Flow

USGS Earth Explorer and then these images were imported to Q-GIS/Arc GIS to create a hill shade view. Digital Elevation Model of Bengaluru was obtained from clipping of the required shape file area from the obtained satellite images. Land-use/Land cover Map was obtained using Landsat 8 band combinations 5-4-3 (F.C.C.) in ArcGIS to convert it to raster format. Drainage pattern were extracted from the same tool. The drainage intersection with the urban enclaves are drawn. Intersection point between Drainage Pattern & Urbanization helps us to find zones of urban floods for disaster management.

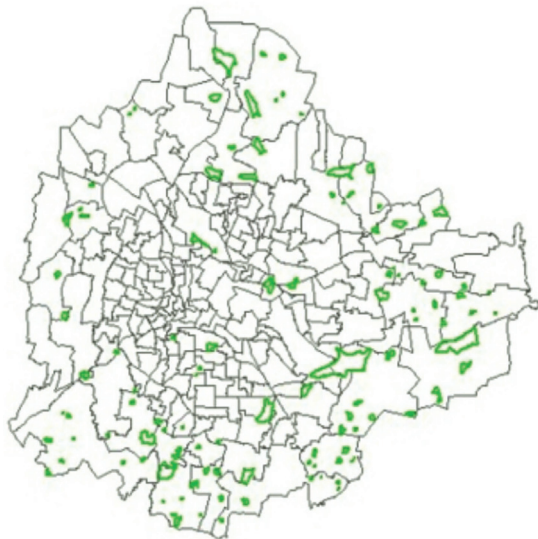
Fig. 9. Existing Tanks in the city

A lesser known fact is that Bengaluru also had a number of tanks. According to the city corporation, (BBMP), the city had 198 lakes. The rapid urban growth has further reduced to only 38 water bodies currently (Table 3). The best practices’ that was used to harvest water in the city was through tanks but now their number and area reduced (Figure 9). These tanks earlier had the capacity to hold runoff and prevent flooding but now this might result in
