# Preventive Measures for Landslide Disaster: A Case Study of Shimla District

Sudhir Kumar

## ABSTRACT

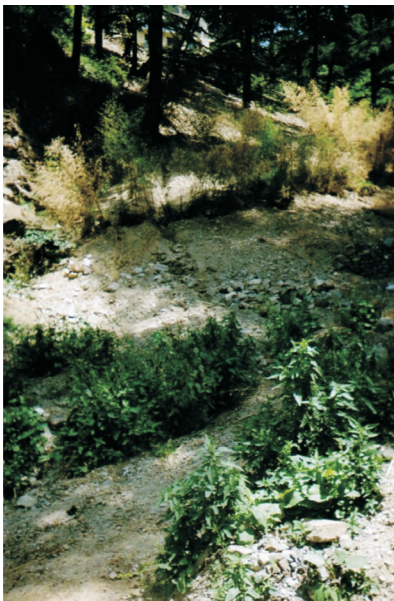
**Plate 1.** Bamboos are grown to stabilize debris slide near Bishop Cotton School

Bamboo Check Dam technique is adopted by the people near Bishop Cotton School, towards Khalini

in Shimla town (Plate-1). When bamboos will start growing, their roots will keep soil bounded and this will minimize the slide of colluvium. Bamboo Check Dam Technique was use near Bishop Cotton School.

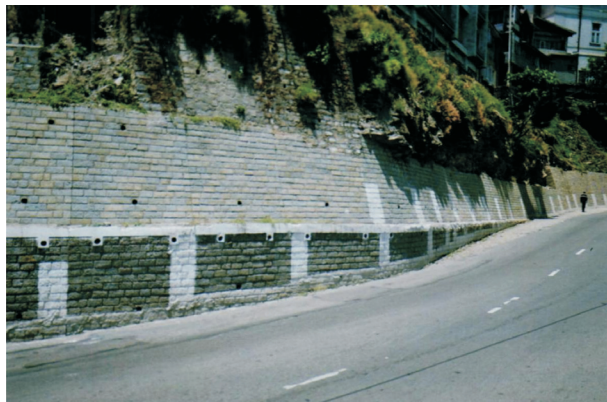
**Plate 2.** Toe Wall under Vidhan Sabha

A most commonly adopted structural measure in the study district is the toe wall. A toe wall is made up of concrete and stones. It is constructed towards the hillside slope to reduce and minimize landslides. In some places where the height of the slide is less toe walls are constructed in a single step wall. In some places where the slope height is very high terraced walls are built up. One such toe wall is being observed below Vidhan Sabha (Plate-2). It was observed during the field survey that construction of toe wall in Kufri area has also been adopted to minimize the landslide.

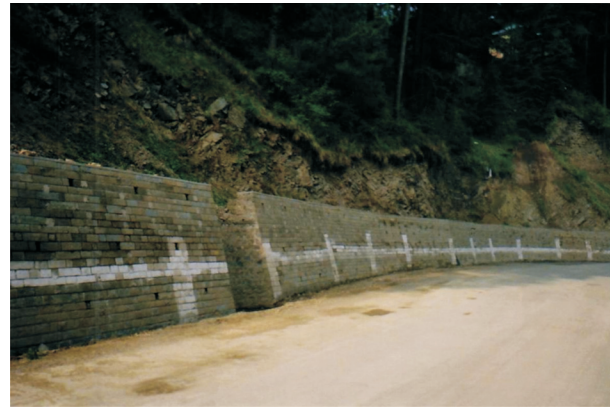
**Plate 3.** Toe Wall in Kufri

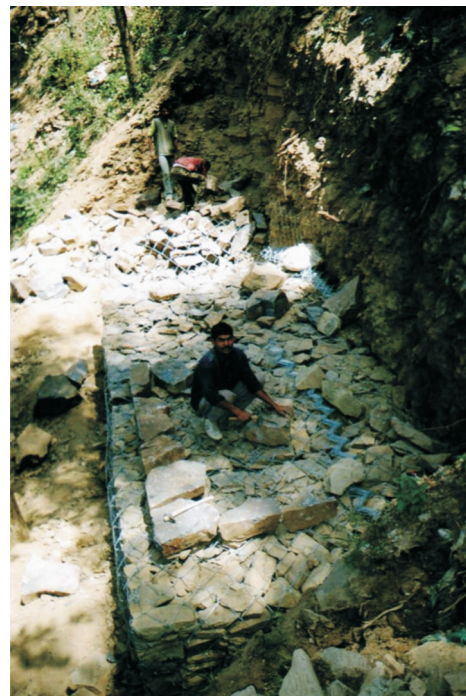
**Plate 4.** Wire Crate structure under construction in Khalini.

Gabion or wire crate structures are emerging within the study district to minimize the impact of landslides. These types of structures are mainly in use along the national highway - 22. Stones are filled in a systematic order in a net made up of iron wires, known as Gabion or Wire Crate Structures. Wire crate structures are used at those places where the frequency of landslides is very high mainly due to heavy rainfall. The structures made up of stones pile within wire net are permeable and flexible. In Vihar village in Khalini in Shimla such wire crate wall was constructed to stabilize the landslides (Plate-3). Another example of four stepped wire crate structure is seen in the Khalini area (Shimla) along the road (Plate-4).

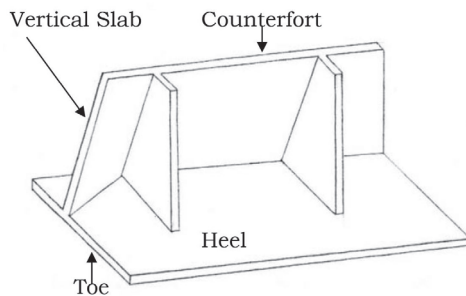
Fig. 1. Counterfort Retaining Wall

Counterfort retaining wall is an another method to mitigate the occurrence of landslides. Counterfort retaining wall is made up of cement, sand, stones and iron rods. Counterfort retaining wall constitutes a vertical slab, counterfort and a heel. Vertical slab lies in the front portion of the wall. Counterforts are the supporting walls attached at the back of the vertical slab at right angle. Heel forms the base of the counterfort retaining wall. On the other hand, the longer portion on which vertical slab is standing

vertically is called toe (Fig.-1 & Plate-5).

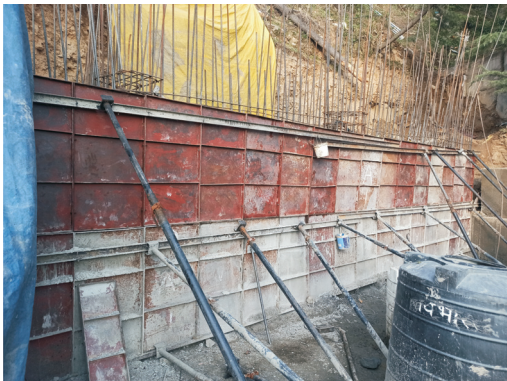
Plate 5. A Construction of Counterfort Retaining Wall in Khalini

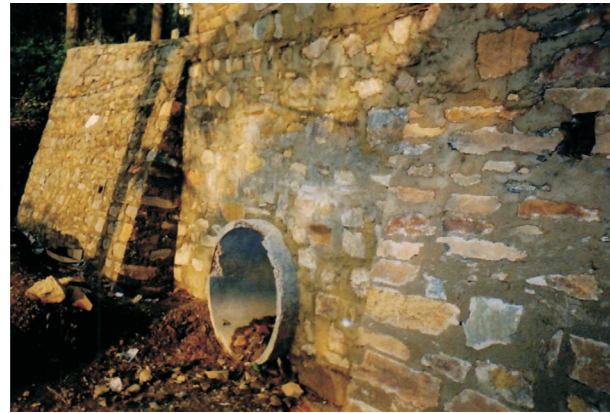
Plate 6. A huge cemented pipe to divert the surface water in Khalini

The surface water acts as a triggering factor for the occurrence of landslides. In Shimla district the impact of surface water is more prominent after heavy rainfall especially during monsoon season. In the study area water has been diverted towards valley side by making horizontal cemented paved channels at the base of retaining walls and breast walls. The cemented paved channels have been seen along the national highway-22 and in the developed inhabited areas such as Kufri, Theog, Narkanda, Rohru, Shimla and Jubbal (Plate-6).

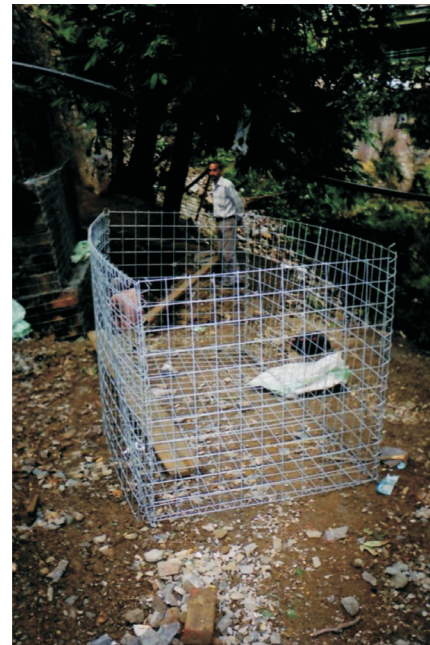
Plate 7. Hard Roll Wire structure near the Lift.

The Public Works Department has come up with a technique called *Hard Roll Wire* structure to stabilize the slope of the study area. This is similar to the wire crate structures but difference is that the thickness of the wire of *Hard Roll Wire* is 6mm and it is rust free. In this, a bucket shaped rectangular wired structure is being prepared which is filled up by stones within it systematically (Plate-7 & 8). This structure easily allows the emission of water out from the wall received during rainfall and restricts the hydrostatic water pressure which leads to the occurrences of landslides.

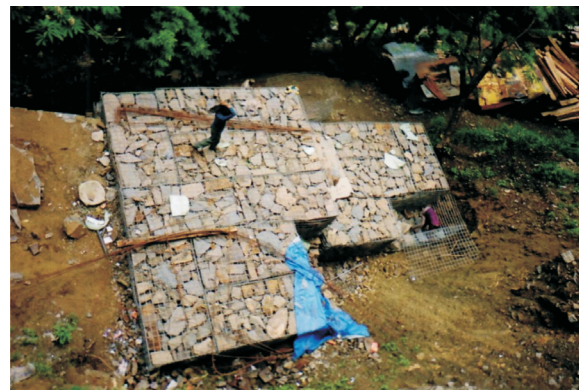
Plate 8. An overview of the Hard Roll wire structure.
