# Influences of Inlet-Outlet System in Santijan Stream of Nagaon, Assam (India): Degradation Issues and Geo-Environmental Challenges

Arup Jyoti Bora<sup>1\*</sup> and Ashok Kumar Bora<sup>2</sup>

*Department of Geography, Gauhati University, Guwahati, 781014, Assam, India*

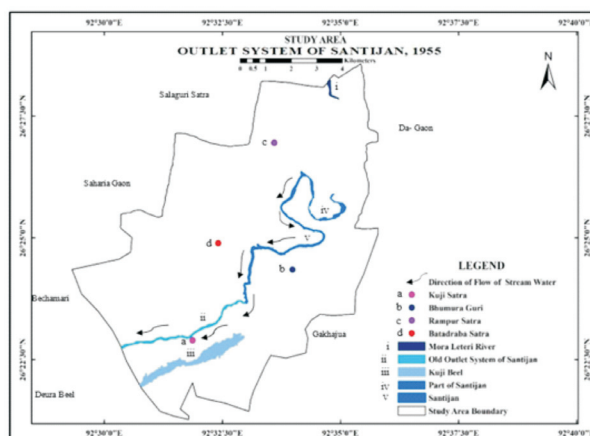
Fig. 5. Outlet system of Santijan, during 1955.

As regards the outlet system of Santijan, some significant changes have also been observed. In 1955 the outlet system of Santijan was on the southern most portion of the stream near the village Batadraba. That portion of Santijan was also connected with Goroimari *Beel* which is not under the present study area. The stream which was interlinked with many *beels* (wetlands), receives flood water of Brahmaputra during rainy season. The surrounding wetlands and the stream have joined together and flowed from north to the south-west direction of the study area.
