Sustainability – A Way of Life in Shirpur, Maharashtra, India

Key words: Shirpur, Angioplasty of water, Sustainability

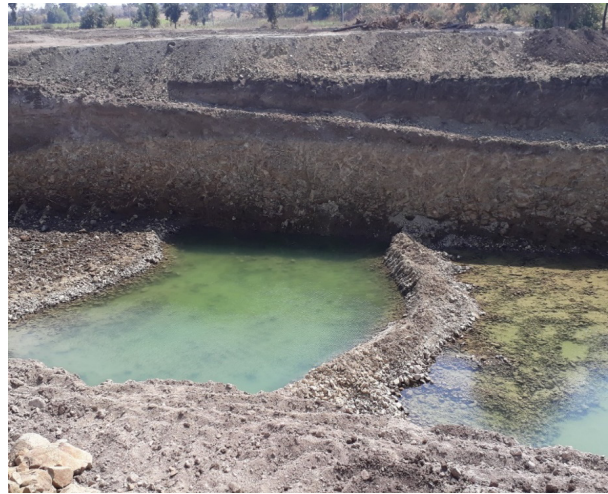
Fig. 1. Bunds dugout in the soil at Shirpur

To overcome this problem, 14 tiny rivulets in the project area were broadened up to 20 to 30 metres and deepened up to 10 to 15 metres from its origin in the Basalt and Alluvial land. Additional water of dams was injected into 59 dry dug wells having the depth of 50 metres, directly with proper filtration.

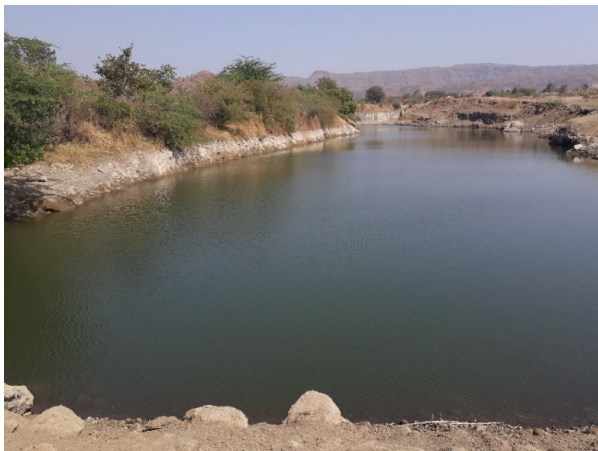
Fig. 2. After Angioplasty in Water Conservation at Shirpur

Figures 2 and 3 depict the scenario in the study area after completion of the project of angioplasty of water in the year 2018 at Shirpur. The photos show the easy availability of water in this area as a result of successful implementation of this project.

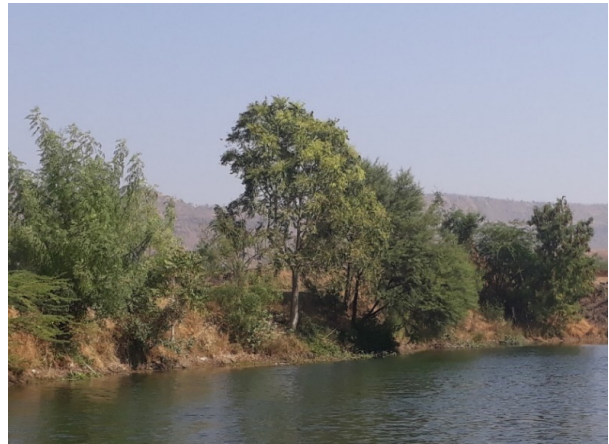
Fig. 3. After Angioplasty in Water Conservation at Shirpur
